# Homer Hadley Floating Bridge 2007 Random Watertight Inspection

Transportation Commission Resolution 398

January 10, 2008

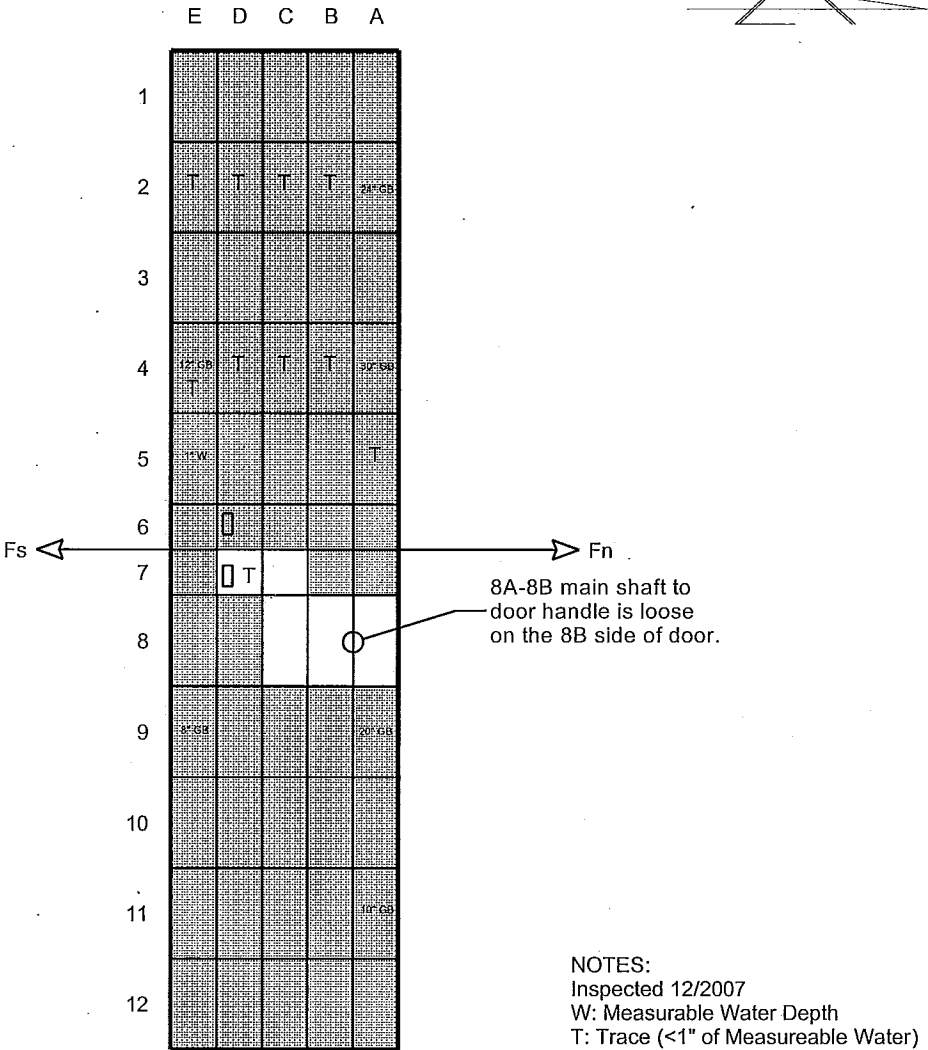
## PONTON E

One loose hatch door was found in Pontoon E between cells 9A and 9B. The door handle wheel is loose to the shaft in Pontoon F between cells 8A and 8B on the 8B side. The following hatch items were found in Pontoon G: The door handle wheel is loose to the shaft between cells 5A and 5B on the 5B side. The door handle wheel is loose to the shaft between cells 8C and 9C on the 9C side. The door handle wheel is loose to the shaft between cells 10C and 11C on the 11C side. One dog arm is not connected to the hub between cells 11C and 11D. Following items were found in Pontoon K: The door handle wheel is loose to the shaft between cells 4C-5C on the 5C side. Cell 4E has a 10"x6"x2" deep spall with one 4" length of exposed rebar in the southeast corner at the interface of the wall with the soffit. The door handle wheel is loose to the shaft between cells 5C-6C on the 6C side.

<u>PONTOON</u>	<u>CELL</u>	<u>COMMENTS</u>
E	8D	Trace of Water
	9A	Door 9A-9B Loose; Rattles When Shut

- Pontoon E, Cell 9A: Repair the hatch door between cells 9A and 9B (Priority 2 REPAIR #14401).
- Pontoon F, Cell 8B: Repair the loose door handle wheel/shaft connection at interior hatch 8A-8B (Priority 2 REPAIR #14401).
